NITROTRAPP®

NITRATE REMOVAL SYSTEM FAILURE
THE DESIGN IS WRONG – NOT THE MEDIA

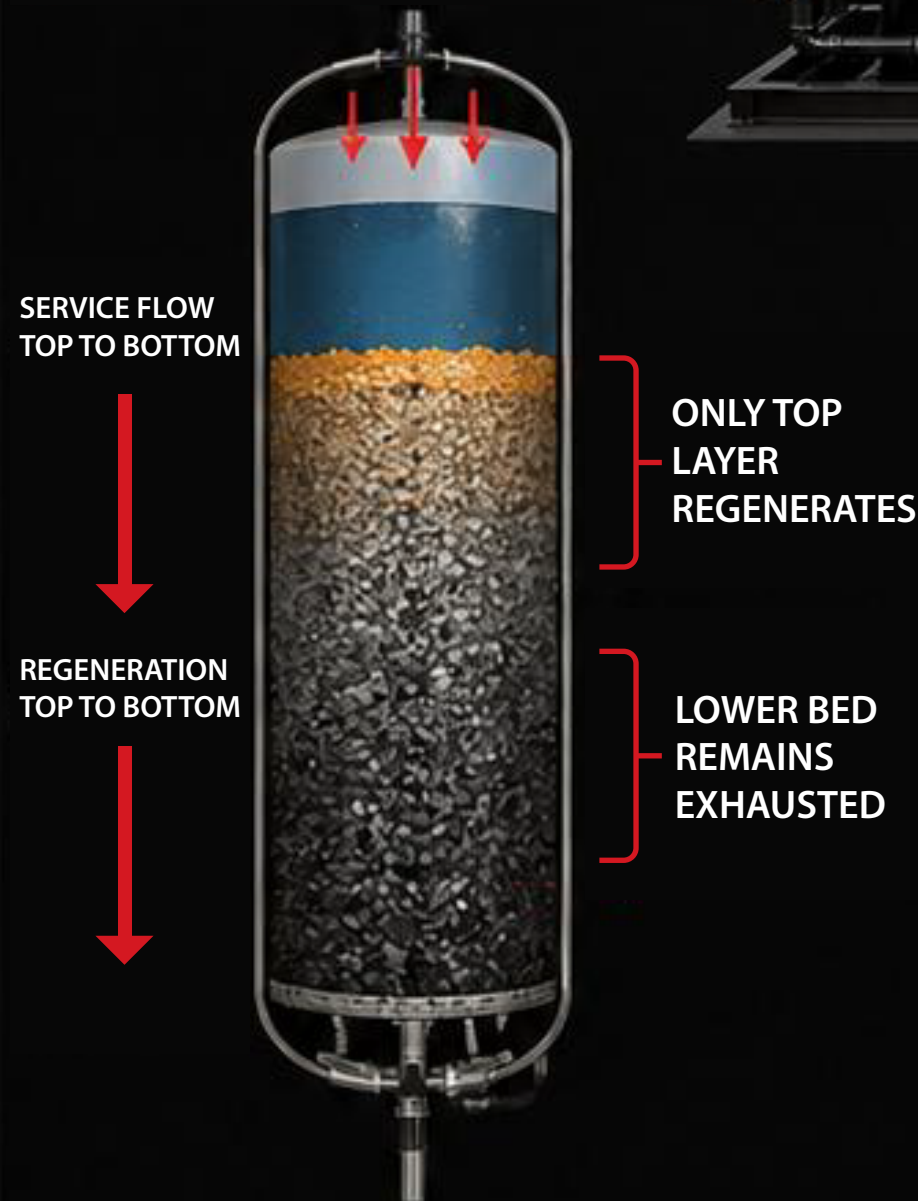
WRONG FLOW – CO-CURRENT TOP → BOTTOM

- ✗ **WRONG FLOW DIRECTION**
Service: Top → Bottom
Regeneration: Top → Bottom
SAME DIRECTION
- ✗ **SHALLOW MEDIA BED**
Only -300 mm media
NO CONTACT TIME
NO MASS TRANSFER
- ✗ **NO DISTRIBUTION SYSTEM**
Channeling
Dead Zones
- ✗ **FAST BRINE PASSING**
Brine does not penetrate full bed
- ✗ **NO PROPER REGENERATION**
No Displacement rinse
No slow rinses
- ✗ **NO TRUE BACKWASH**
Bed not expanded
Media compacted

RESULT • ONLY TOP LAYER WORKS • LOWER BED DEAD • NITRATE BREAKTHROUGH
